# **Trunk Lid Liner**

# Installation Instructions

906-400 Red "Roadster" Script	Miata 90-97	906-404 Silver "Roadster" Script	Miata 99-05
906-401 Red "Roadster" Script	Miata 99-05	906-405 Silver "Roadster" Script	Miata 06-15
906-402 Red "Roadster" Script	Miata 06-15	906-406 Plain (No Script)	Miata 90-97
906-403 Silver "Roadster" Script	Miata 90-97	906-407 Plain (No Script)	Miata 99-05

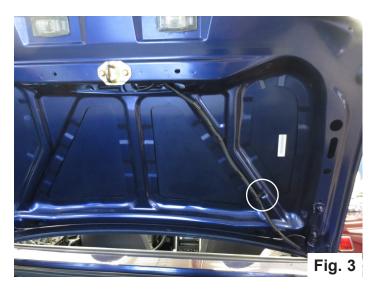
3) 1999-2005 owners may need to adjust the wiring harness from one side of the hold down to the other. Use a razor blade to carefully cut the loom away from the hold down. Remove the old electrical tape. Move the harness to the back side of the hold down and re-tape it in place. See Figure 3.

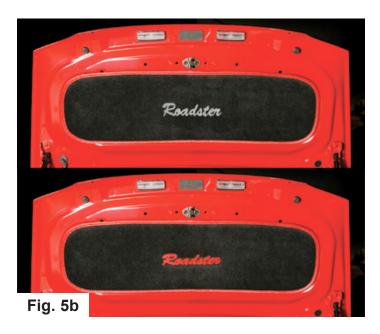
The 906-402 (red "Roadster" script) and the 906-405 (silver "Roadster" script) trunk lid liners installed on a 2006 Miata. Figure 5b.
